Aquia Dam. Inventory Number: VA-17911.
Potomac River Basin. Stafford County, Virginia.
Phase I Inspection Report.

AQUIA DAM - LAKE SMITH IMPOUNDMENT
STAFFORD COUNTY, VIRGINIA
INVENTORY NO. VA 17911

**Deward M. Martin & Associates, Inc.
January 1979**

Name of Dam : Aquia Dam, Lake Smith Impoundment
State : Virginia
County : Stafford
Stream : Aquia Creek
Date of Inspection : December 4, 1978

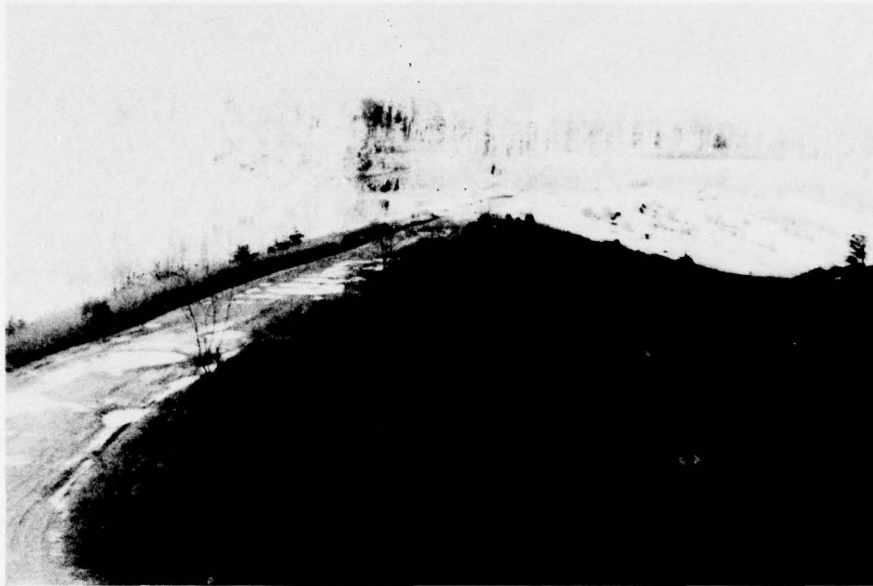
Top of Dam
(Looking North)

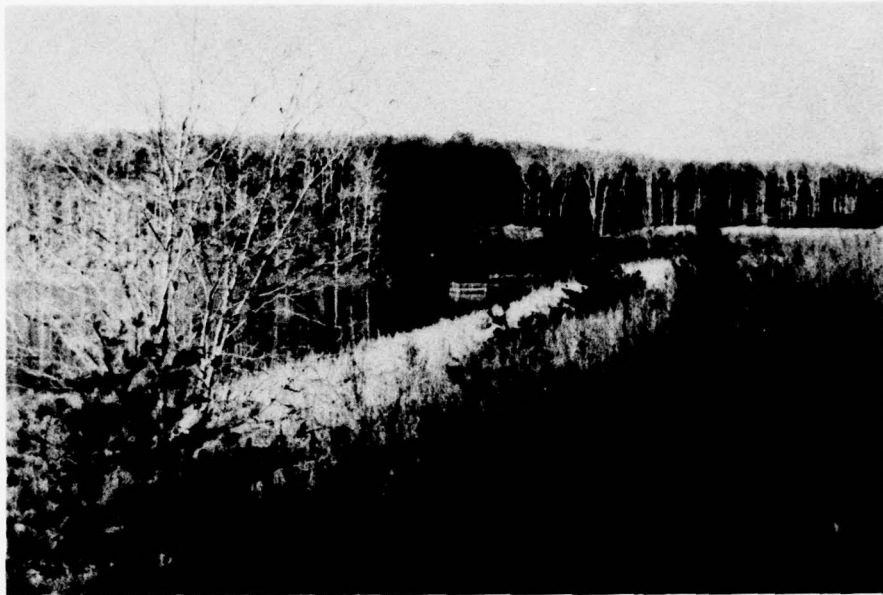
PHOTOGRAPH NO. 1
Upstream Face of Dam
Principal Spillway Intake Structure

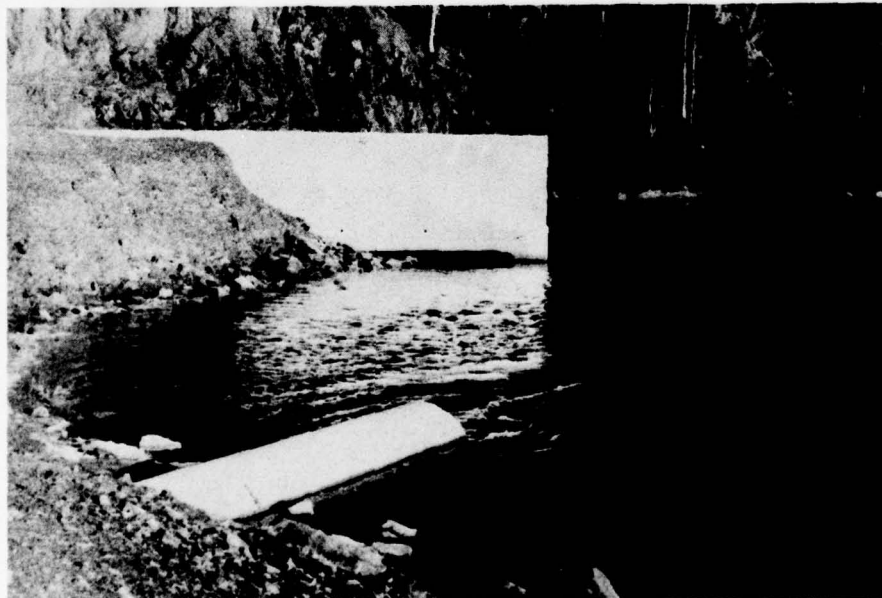
1. Toe drains were silted shut.
2. 60-inch diameter outflow pipe was partially submerged. Riprap at the outlet was not visible. Erosion was noted under the pipe cradle.
3. Erosion has occurred under the lower end on the concrete emergency spillway, which is opposite and downstream from the 60-inch diameter outflow pipe.
4. Rock debris in the downstream channel tends to obstruct normal flow.

The 60-inch diameter principal spillway outlet pipe is located in such a position that together with the lack of sufficient riprap, the discharge erodes under the emergency spillway structure. The outlet area needs protection against discharge erosion by an addition of riprap.

PHOTOGRAPH NO. 2
Principal Spillway Outlet Pipe
& Erosion under Emergency Spillway

7.1.4 There is insufficient riprap in the area around the end of the principal spillway pipe and the velocity of the discharge water is sufficient to cause erosion under the emergency spillway structure. Riprap must be installed and the erosion repaired.

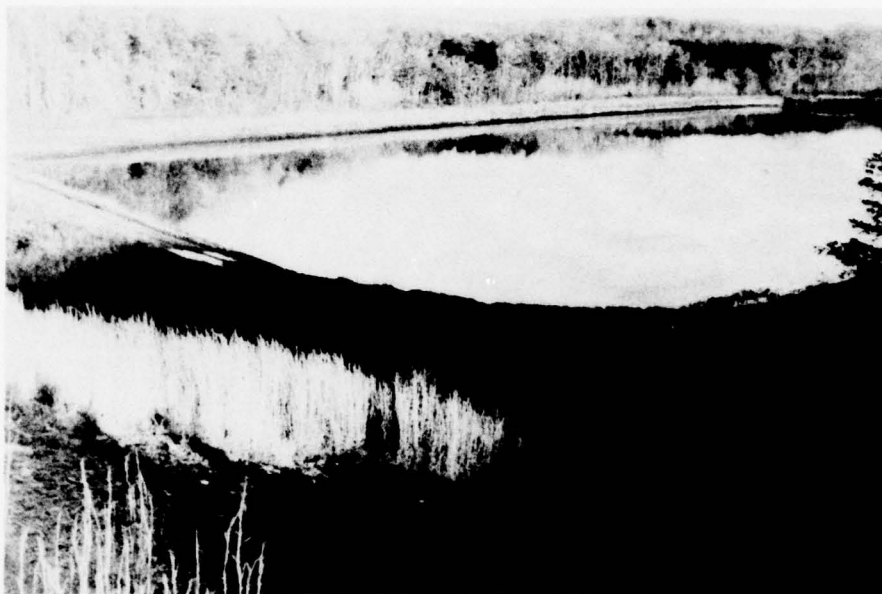
PHOTOGRAPH NO. 3
Lagoon Below Dam

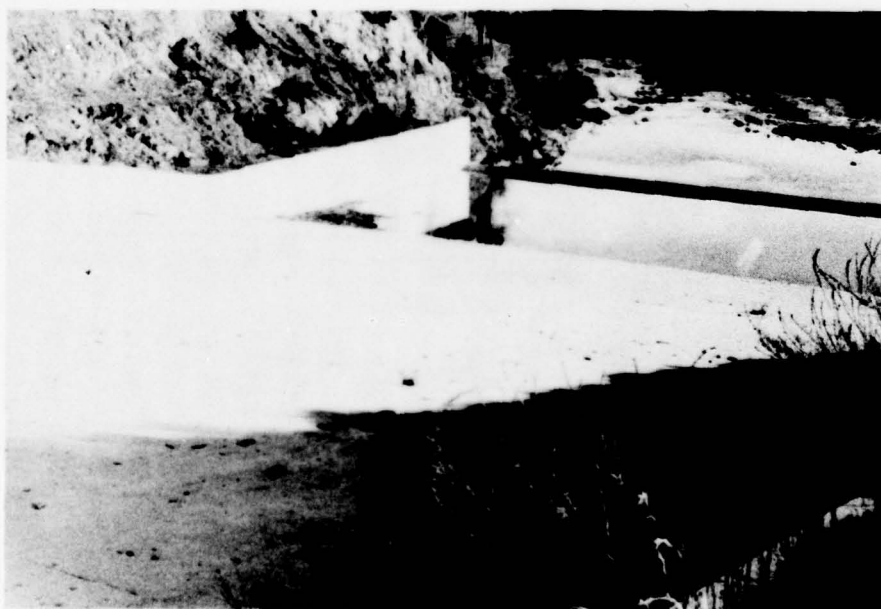
PHOTOGRAPH NO. 4
Emergency Spillway
Downstream Channel
